Manhole Inspection Summary

Manhole # S35W1_001MH

Insp Date: **11/29/07 7:45 AM**

Location Address: **3700 Potee St**

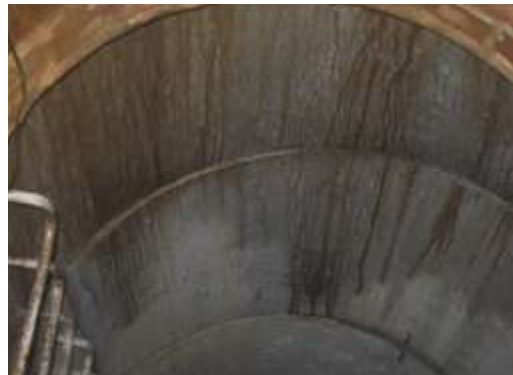
Defect 2

Infiltration: ☐ None ☒ **Joint** ☐ Cracks ☐ Mortar ☐ Roots ☐ Wall

Infiltration

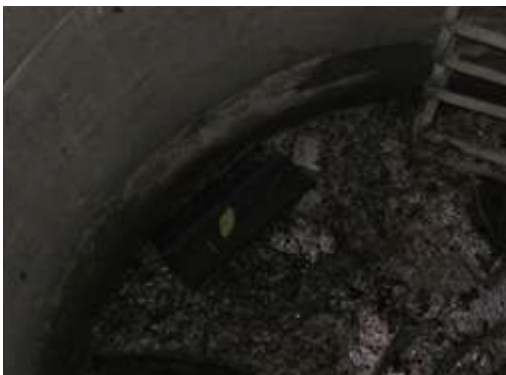
Defect 1

Object on bench

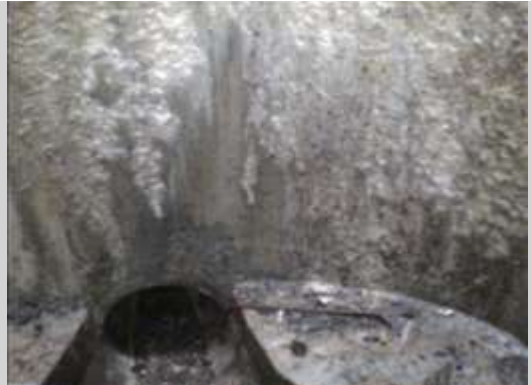
12 O'Clock Outflow

10 in. Circular Gravity Sewer
Pipe Out @ 12 O'Clock

Pipe Height: **10.8** (in.) Rod and Bar (Angled)
Pipe Material: **DIP/CI** ☐ Pipe Lined
Invert Depth: **15.72** (ft.) Flow Characteristics: **None**
Deposits: ☒ None ☐ Mud ☐ Sludge ☐ Debris ☐ Grease
Silt Depth: (in.) Deposits Extent:
Infiltration: **None** Pipe Seal Cond: **Sound**

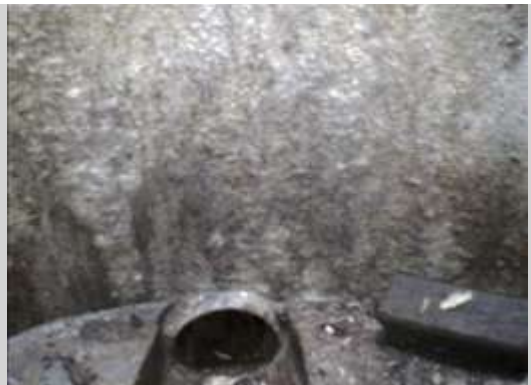
3 O'Clock Inflow

10 in. Circular Gravity Sewer
Pipe In @ 3 O'Clock

Pipe Height: **9.6** (in.) Rod and Bar (Angled)
Pipe Material: **DIP/CI** ☐ Pipe Lined
Invert Depth: **15.45** (ft.) Flow Characteristics: **None**
Deposits: ☒ None ☐ Mud ☐ Sludge ☐ Debris ☐ Grease
Silt Depth: (in.) Deposits Extent:
Infiltration: **None** Pipe Seal Cond: **Sound**

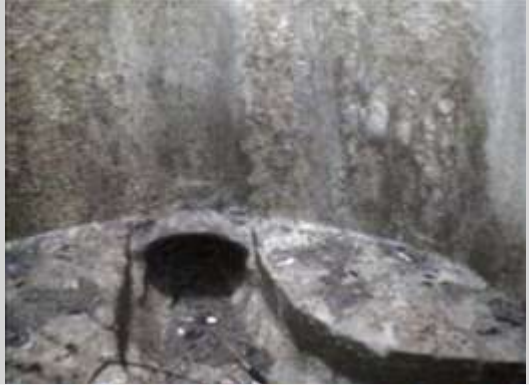
9 O'Clock Inflow

10 in. Circular Gravity Sewer
Pipe In @ 9 O'Clock

Pipe Height: **10.8** (in.) Rod and Bar (Angled)

Infiltration: **None** Pipe Seal Cond: **Sound**
